## Repair kit inner tailgate cover

**Volvo 740, 760, 940, 960, V90 (-1998)**

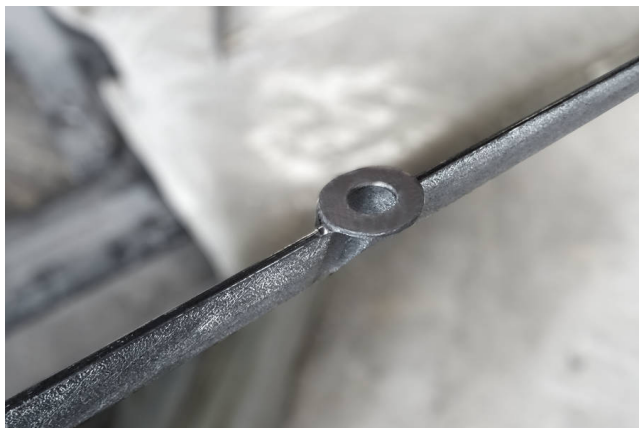
This is how the lower edge of a dismantled tailgate trim should look on a 940. In the centre of the picture, one of the four retaining eyes with which the underside of the trim is attached to the tailgate.

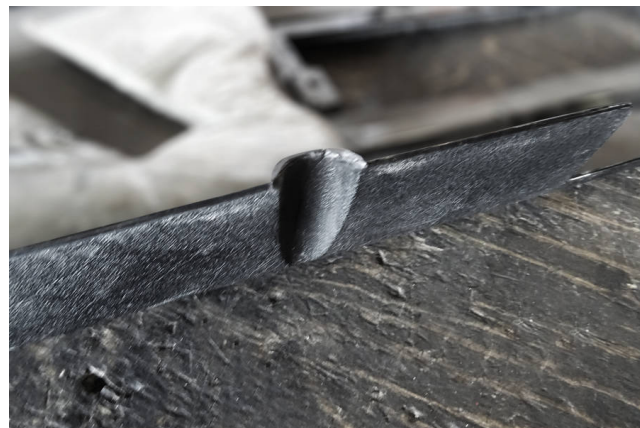
Due to bad treatment or sometimes simply due to brittle plastic, it often looks like that. When individual clips no longer work, the cover does not fall off immediately, but it rattles. The force on the remaining retaining eyelets obviously increases.

Our repair kit solves exactly this problem. It contains four stainless steel plates to replace the retaining lugs. The two outer ends with the 3.5 mm holes must be angled to the lower end of the cut and then form the retaining lugs for riveting to the panel.
